Manhole Inspection Summary

Manhole # S23KK1007MH

Location Address: **4414 FALLS RD** Cross Street: **WOOD HEIGHTS AVE**

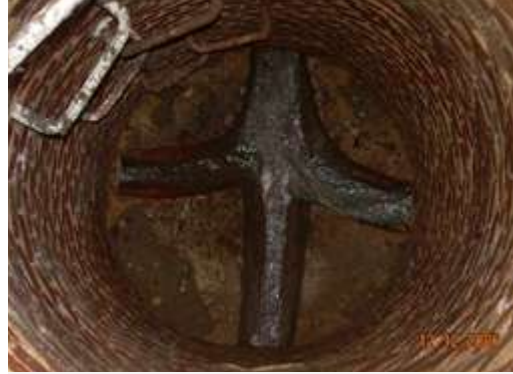
Top View

Corroded steps. Bench debris.

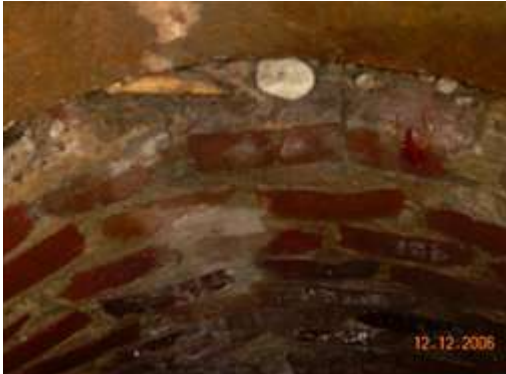
Defect

Frame leaks. Adjustment deterioration and infiltration.

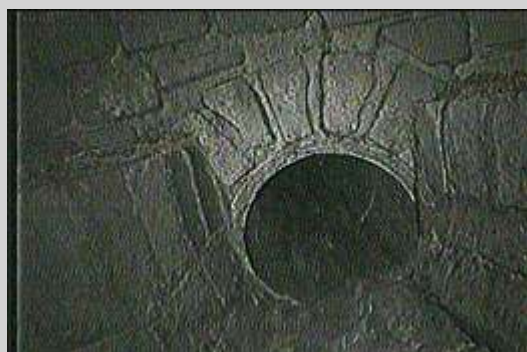
Pipe Out @ 12 O'Clock

Channel deterioration.

Infiltration: **Evidence** Pipe Seal Cond: **Unknown**

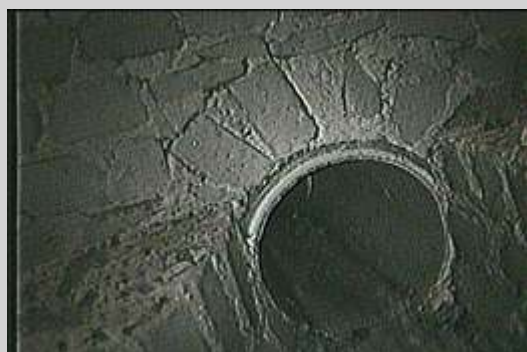
Pipe In @ 3 O'Clock

Infiltration: **Evidence** Pipe Seal Cond: **Unknown**

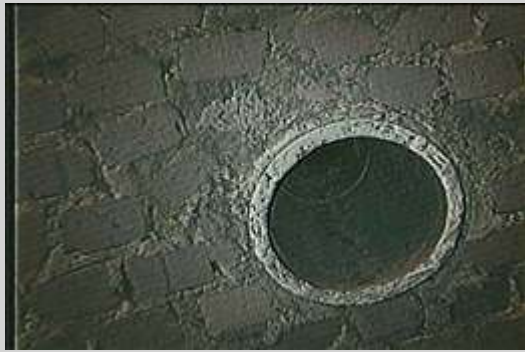
Pipe In @ 6 O'Clock

Infiltration: **Evidence** Pipe Seal Cond: **Cracked**

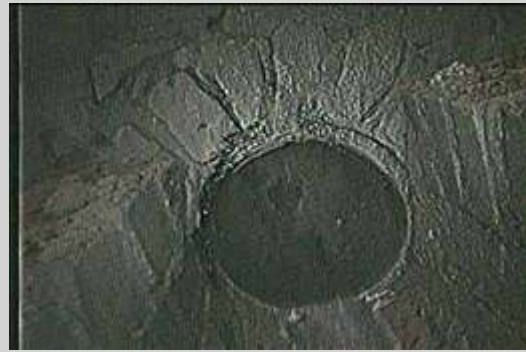
Drop In @ 6 O'Clock

Drop: **Outside** Rod and Bar
Angled: **Yes** Reading: **9.81** (ft.)
Inv Depth: **10.81** (ft.)
Drop Condition: **Open**

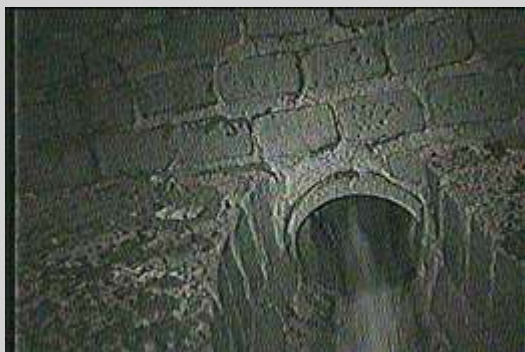
Pipe In @ 9 O'Clock

Infiltration: **Evidence** Pipe Seal Cond: **Unknown**
